NATIONAL ADVISORY COMMITTEE FOR AERONAUTICS

WARTIME REPORT

MEASUREMENTS IN FLIGHT OF THE STABILITY, LATERAL-
CONTROL, AND STALLING CHARACTERISTICS OF AN AIRPLANE
EQUIPPED WITH FULL-SPAN ZAP FLAPS AND
SPOILER-TYPE AILERONS

MEMORANDUM REPORT

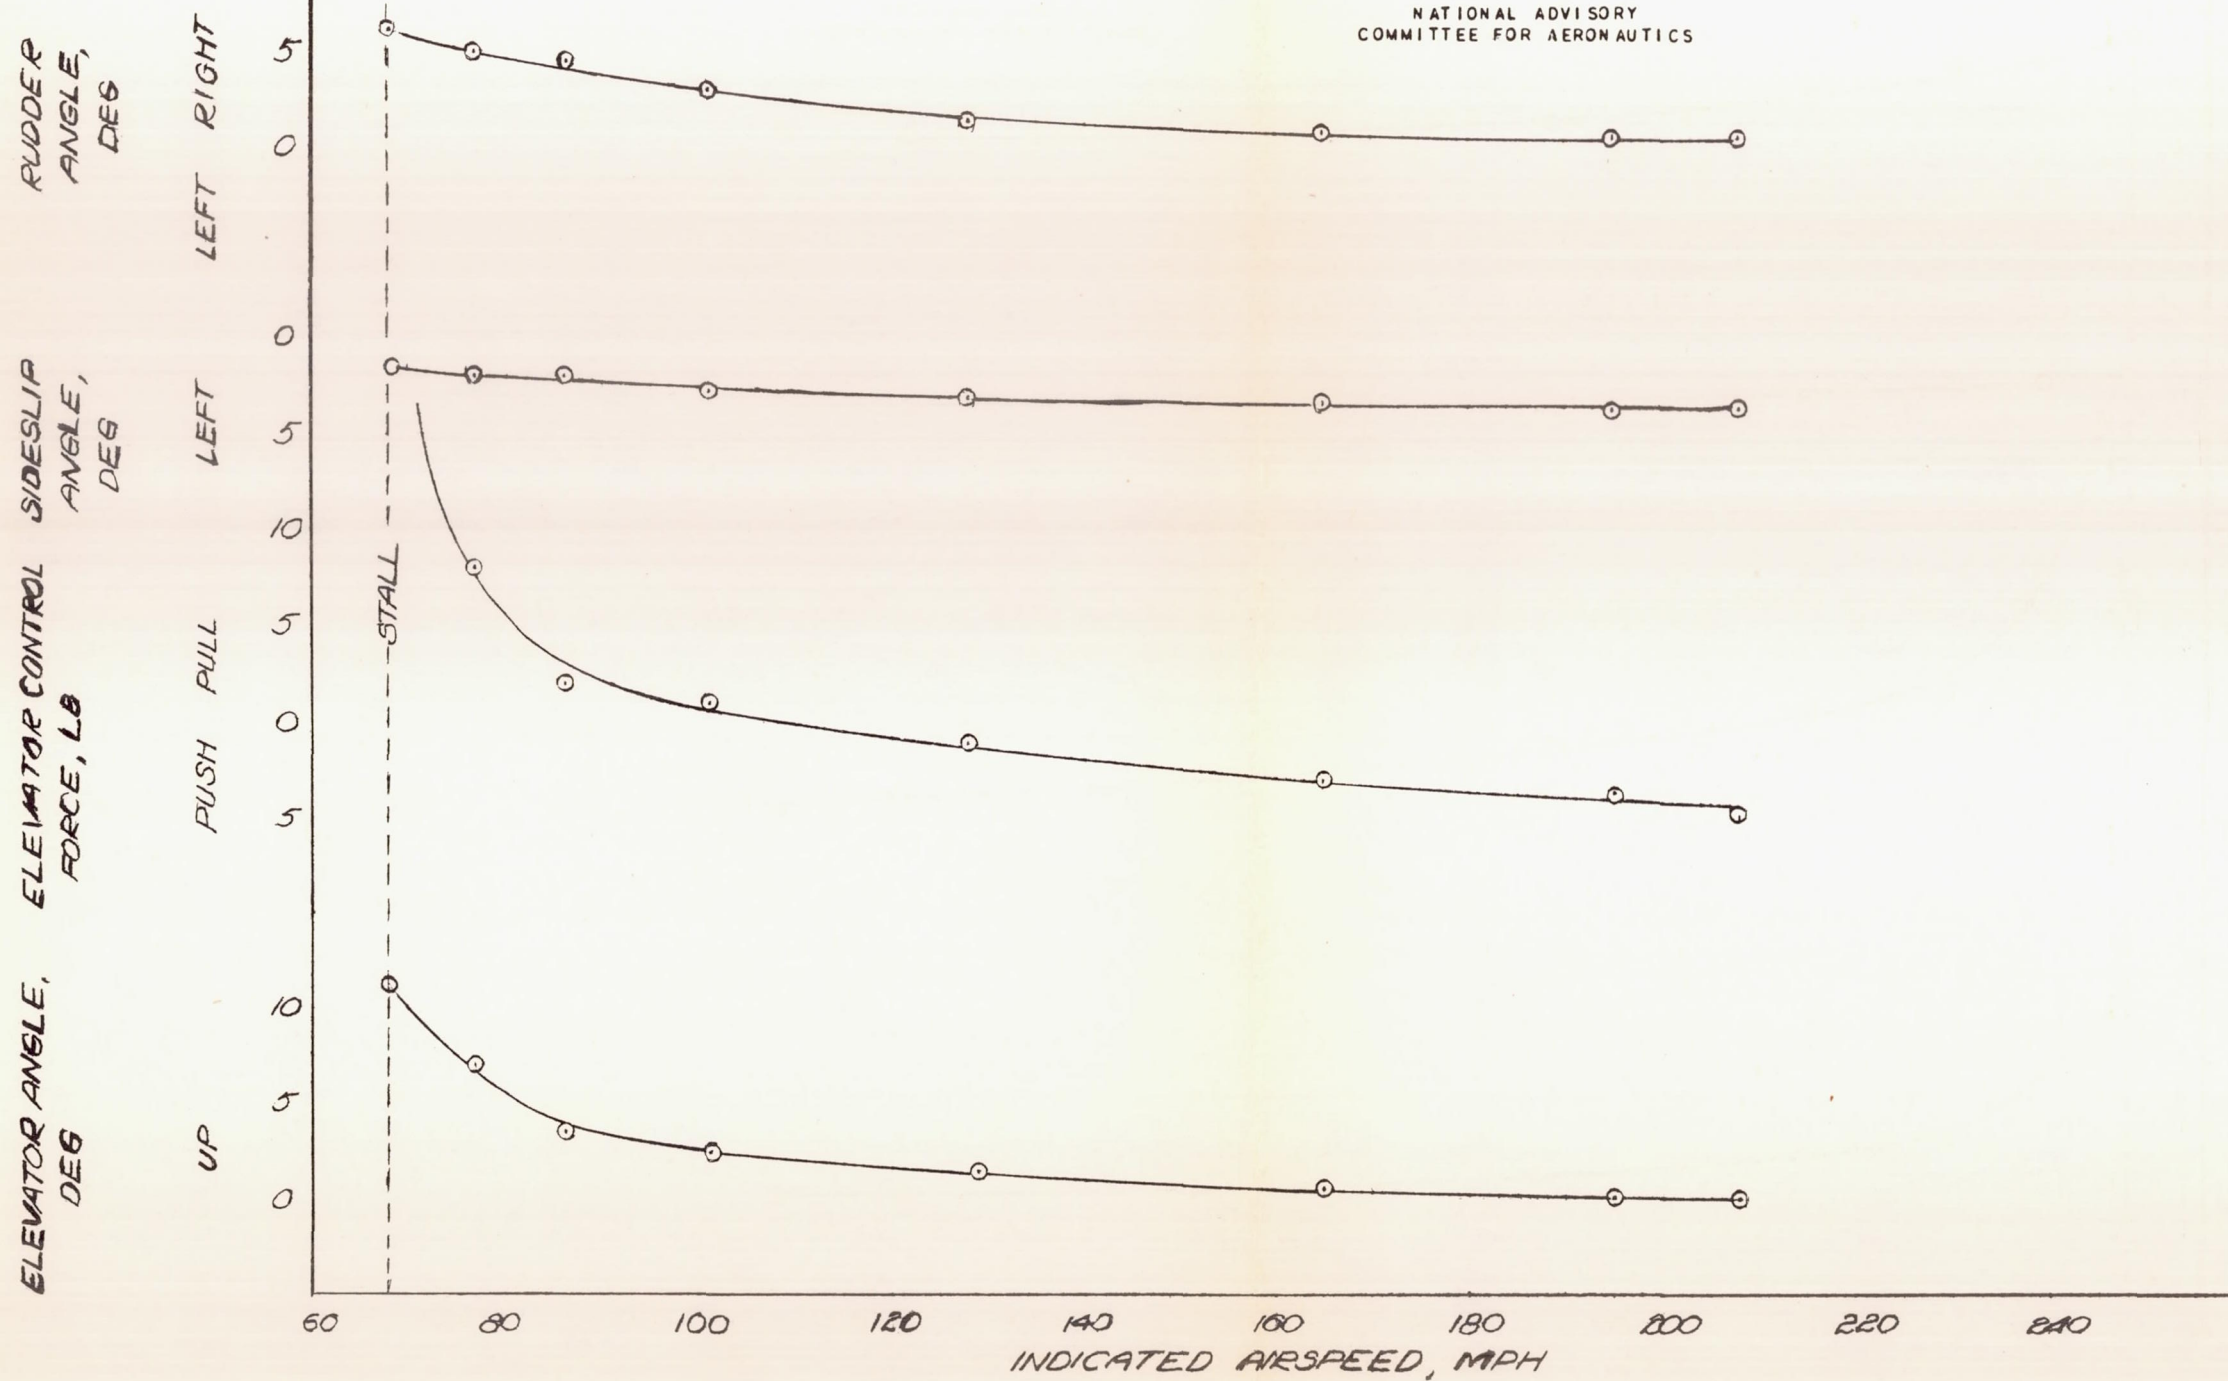
FIGURE 16. - ELEVATOR CONTROL CHARACTERISTICS IN STEADY FLIGHT, CLIMB CONDITION, RATED POWER, FLAPS UP.

Characteristics in steady flight.— The elevator control characteristics in steady straight flight are shown for four flight configurations in figures 16 to 19. From the variation of elevator angle with airspeed, it is seen that the airplane exhibited stick-fixed stability over the test speed range for all four flight conditions.

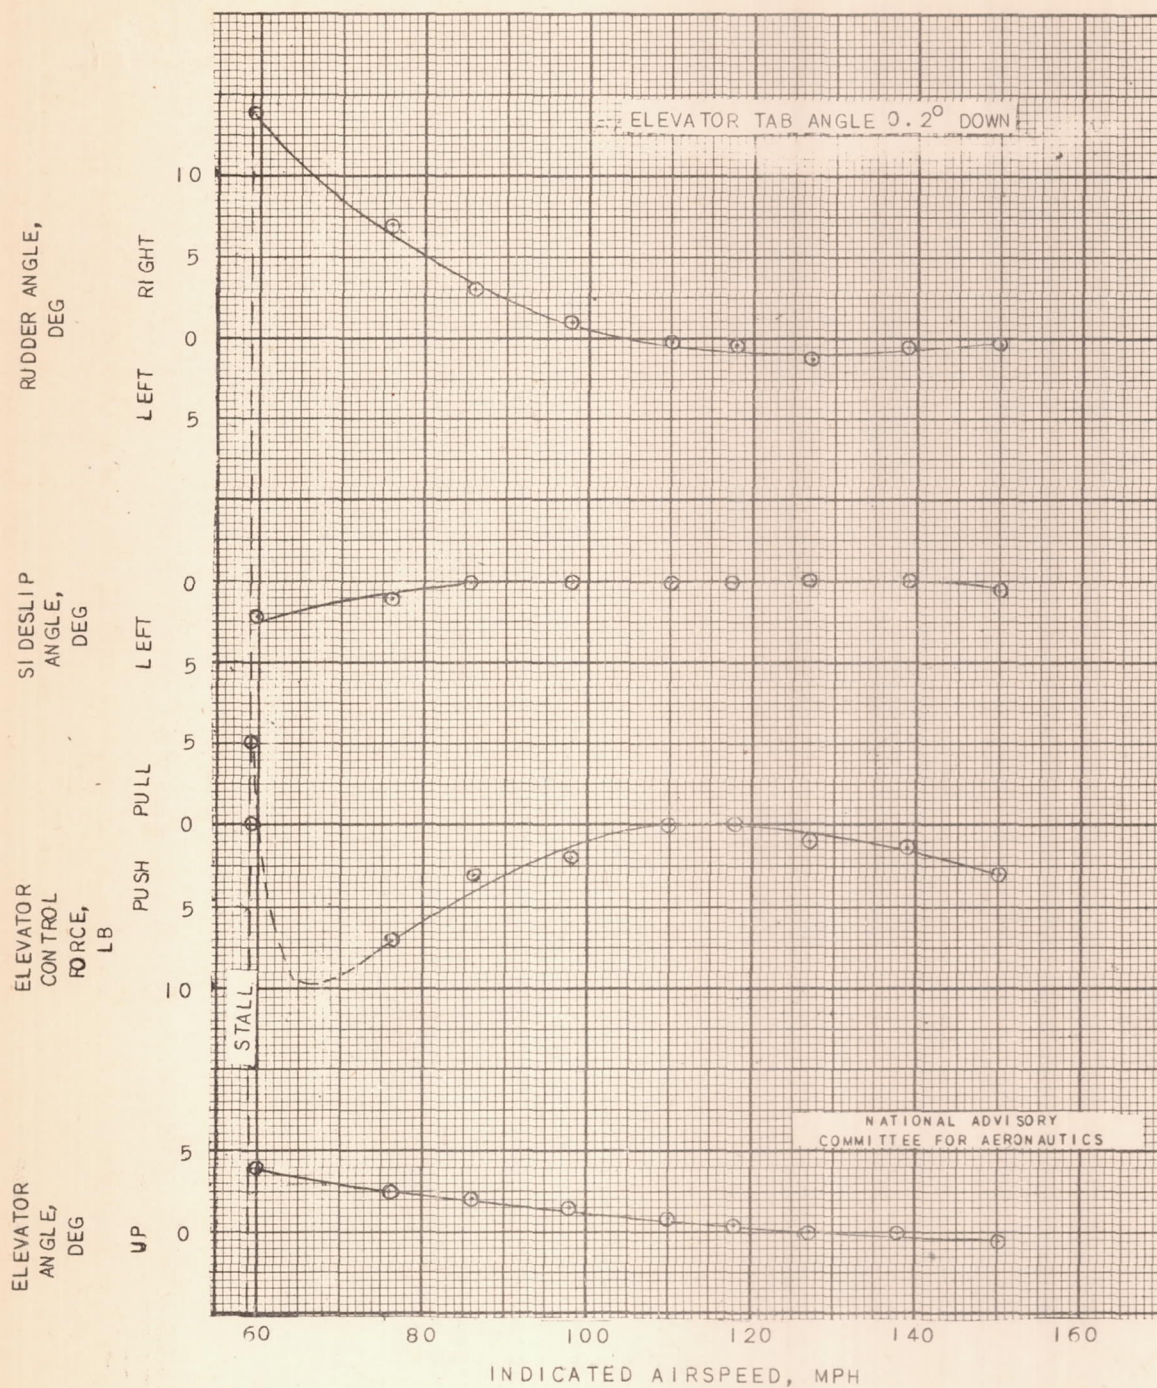
FIGURE 18. - ELEVATOR CONTROL CHARACTERISTICS IN STEADY FLIGHT, WAVE-OFF CONDITION, RATED POWER, FLAPS DOWN.

control-force gradient at trim speed was greater than the minimum value of 0.05 pound per mile per hour as recommended in reference 3 when friction in the control system is low. The friction in the elevator control system of this airplane is approximately 0.75 pound which is less than the maximum value of 2 pounds prescribed in reference 3. For the wave-off condition it is observed from figure 18 that neutral stick-free stability exists at the trim speed.

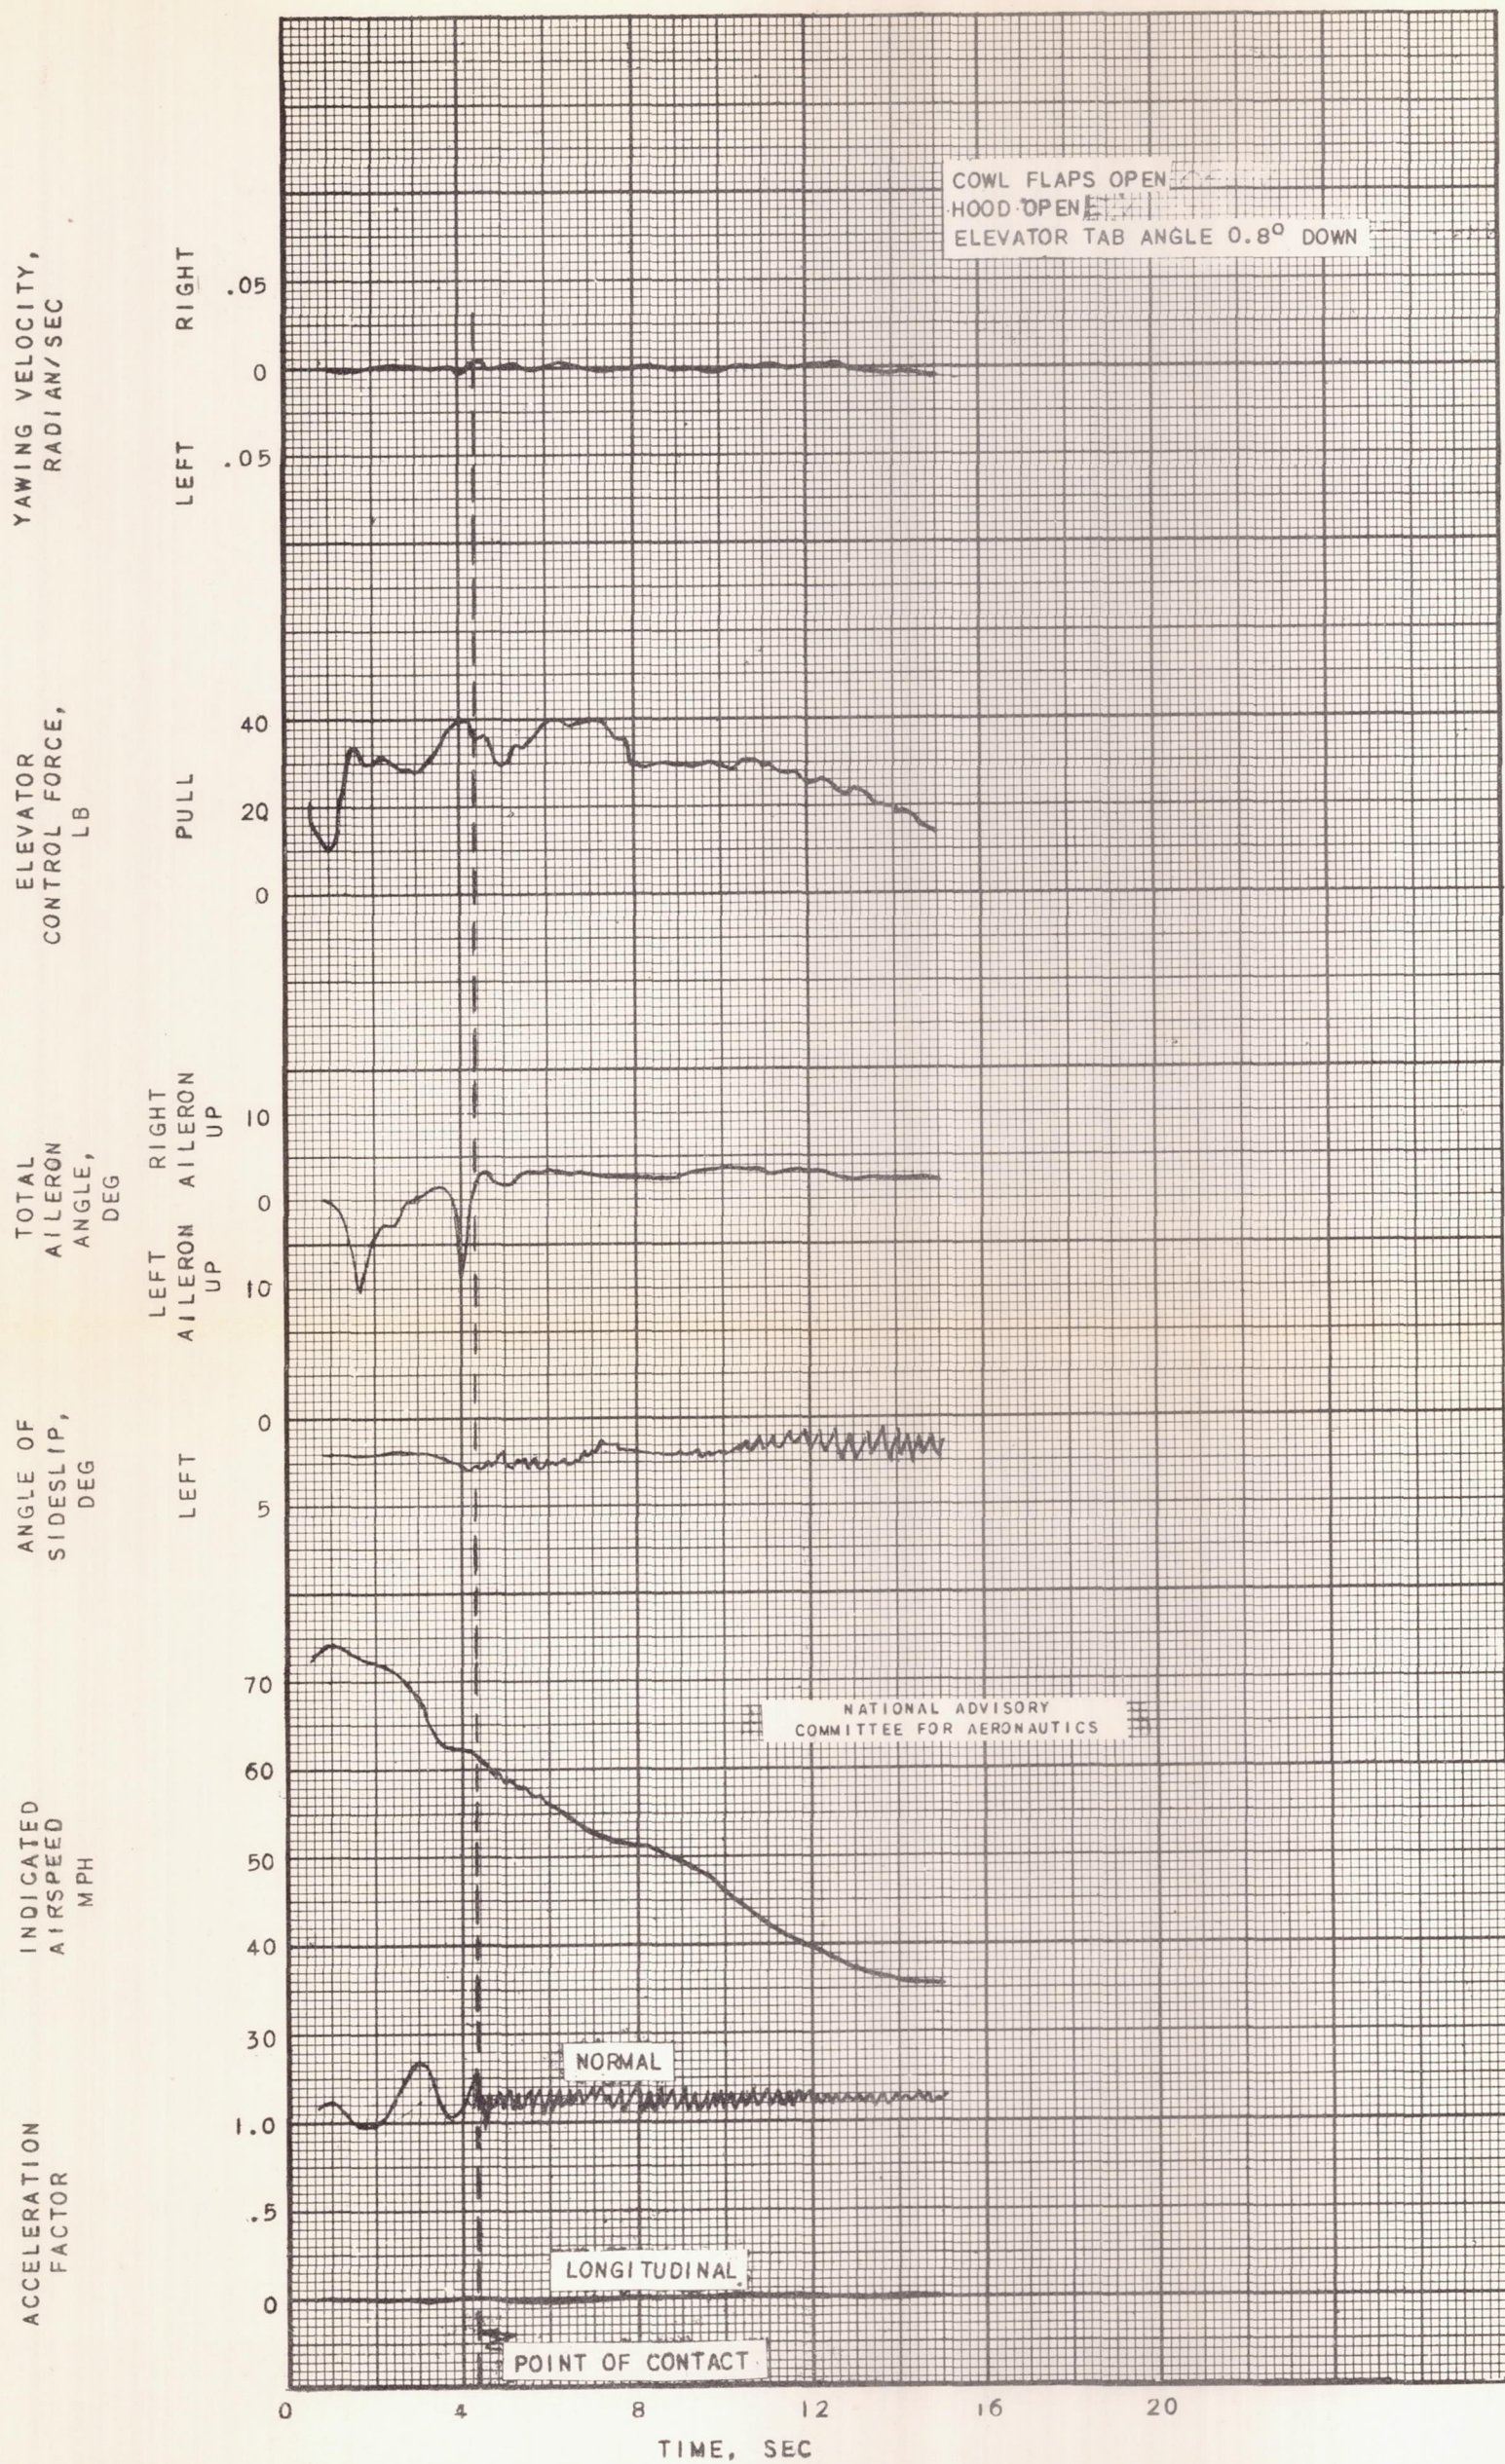
FIGURE 20. - TIME HISTORY OF A THREE-POINT LANDING, POWER OFF, FLAPS DOWN.

Characteristics of the elevator control in landing.— The elevator control characteristics in landing are indicated by the time histories of two landings shown in figures 20 and 21. From the time history of the landing shown in figure 20, it is seen that the amount of pull force necessary to bring the tail down was in excess of the 35 pounds maximum force recommended in reference 3. However, these forces could possibly have been reduced by making use of the additional 12° tab angle available. Figure 21 indicates that the elevator control was sufficiently powerful to hold the airplane off the ground until three-point contact was made.

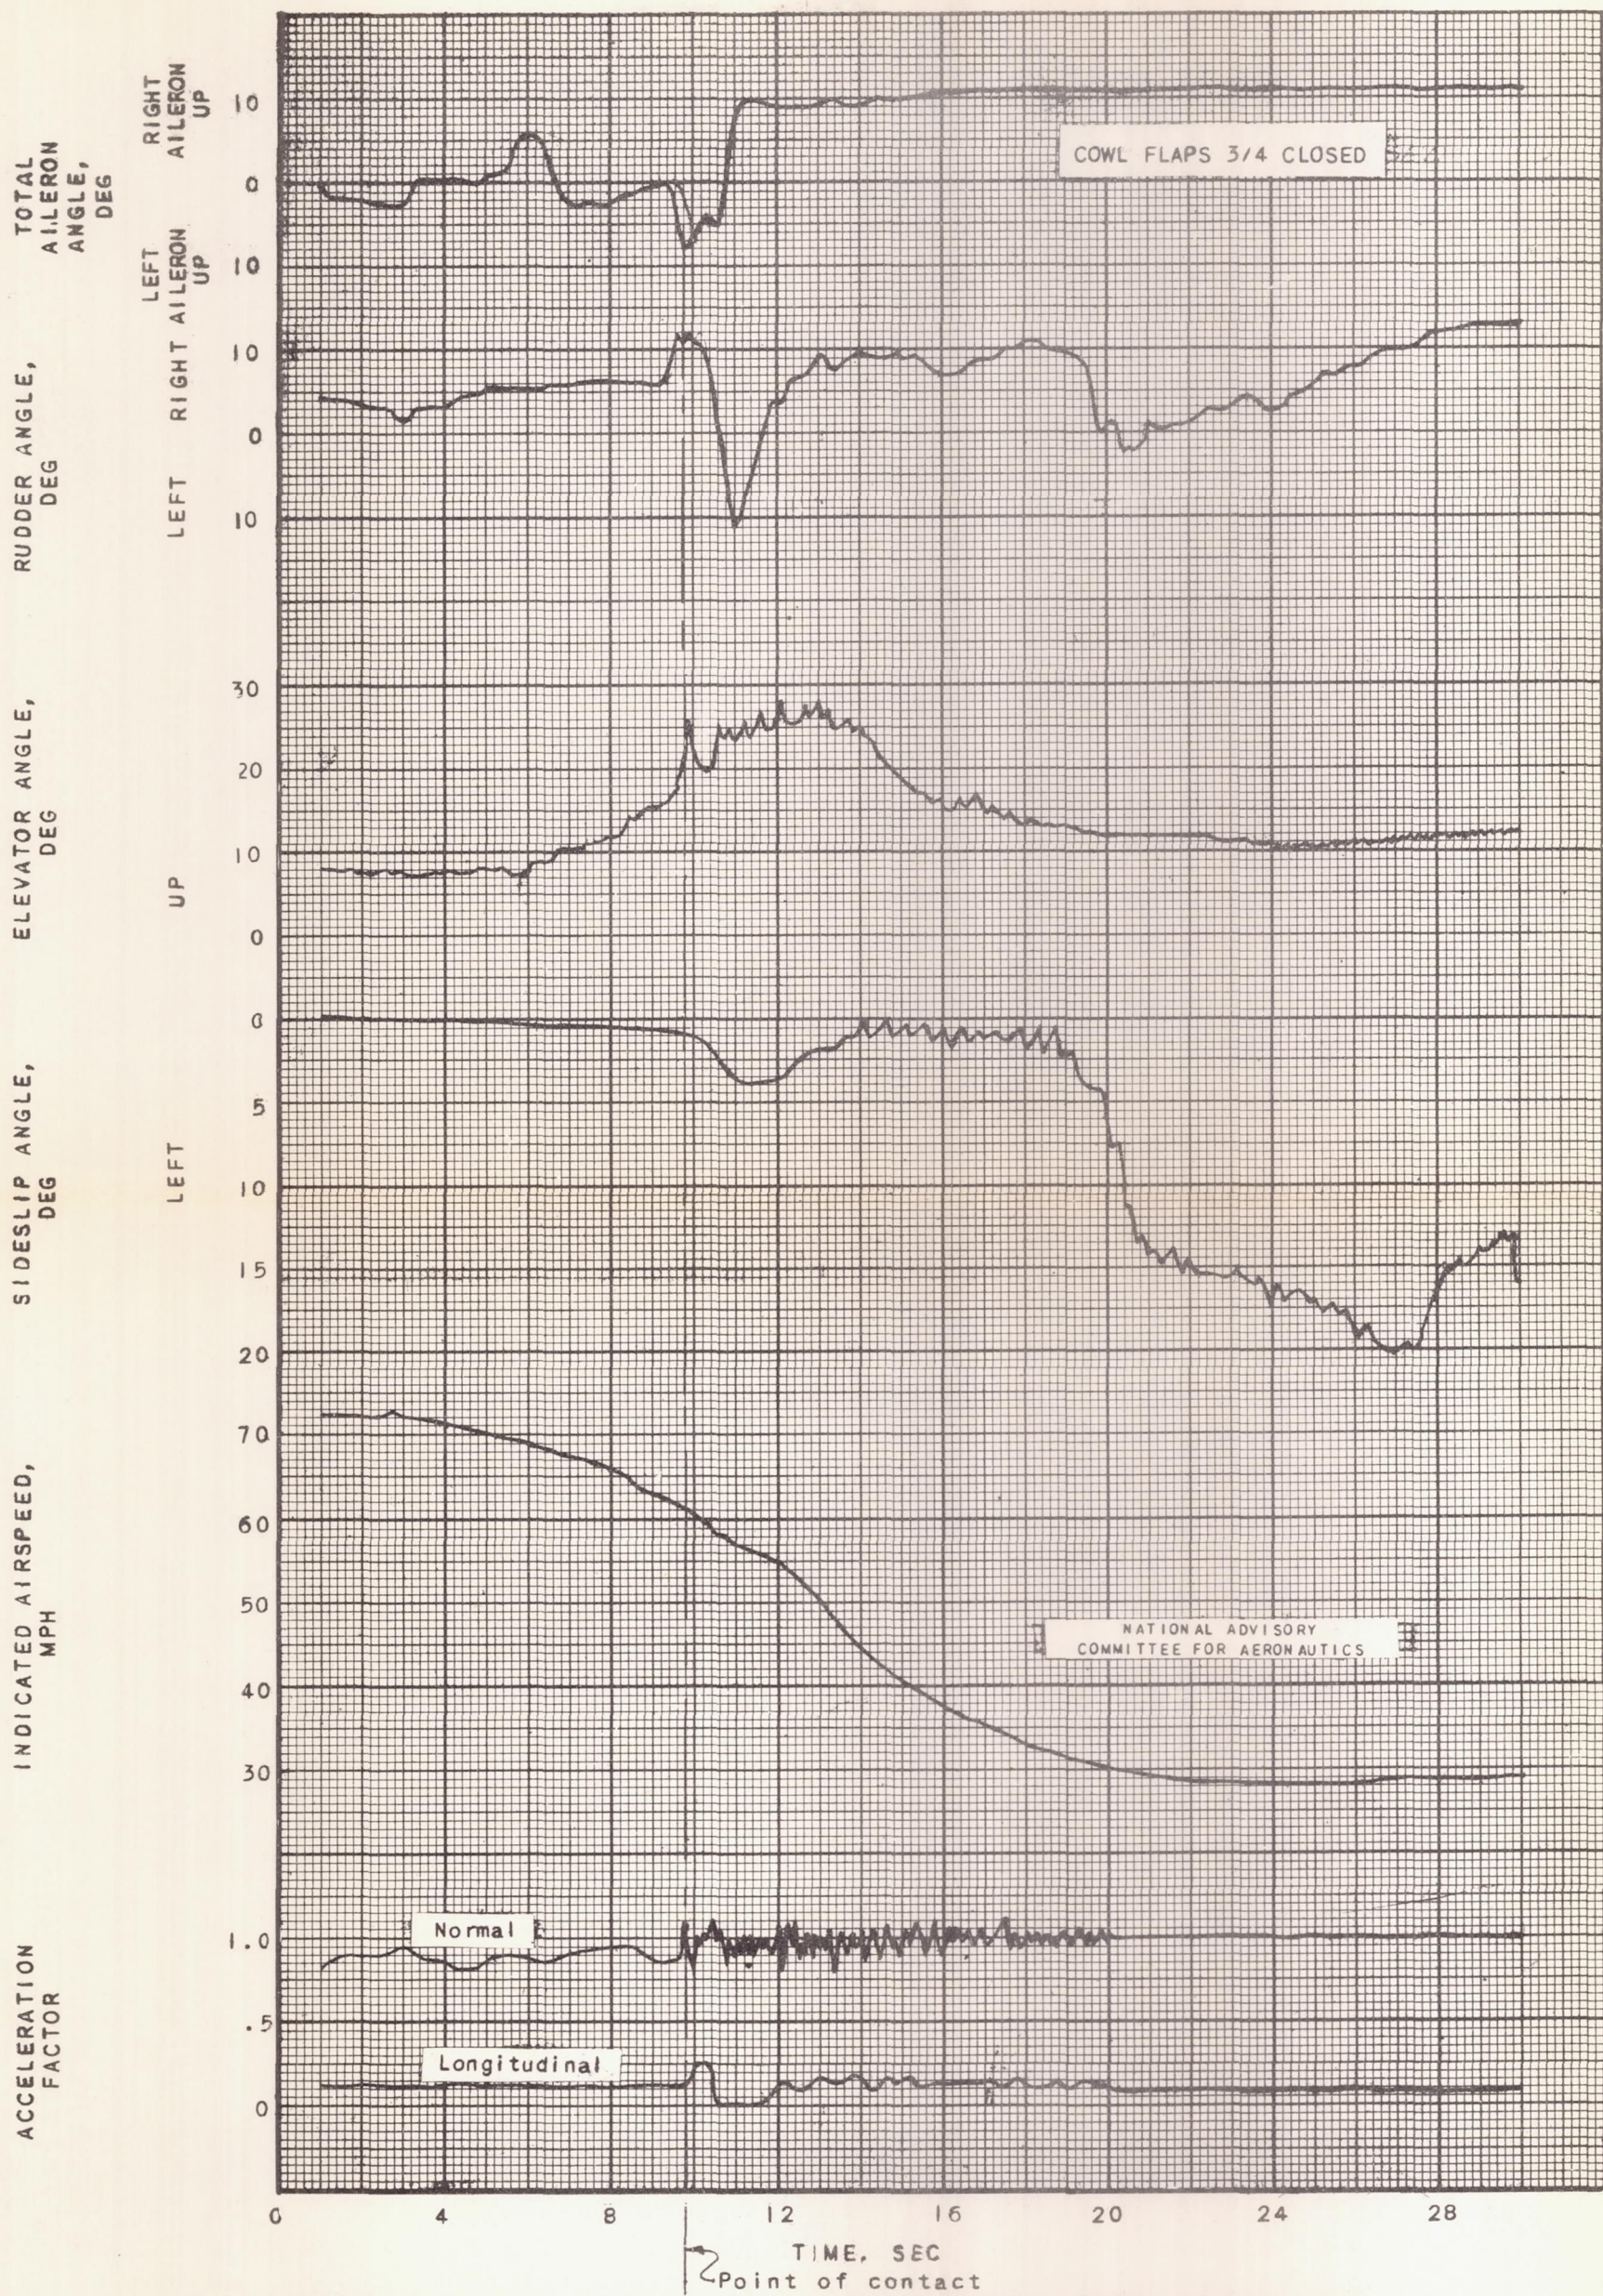
FIGURE 21. - TIME HISTORY OF A LANDING, PARTIAL POWER, FLAPS DOWN.

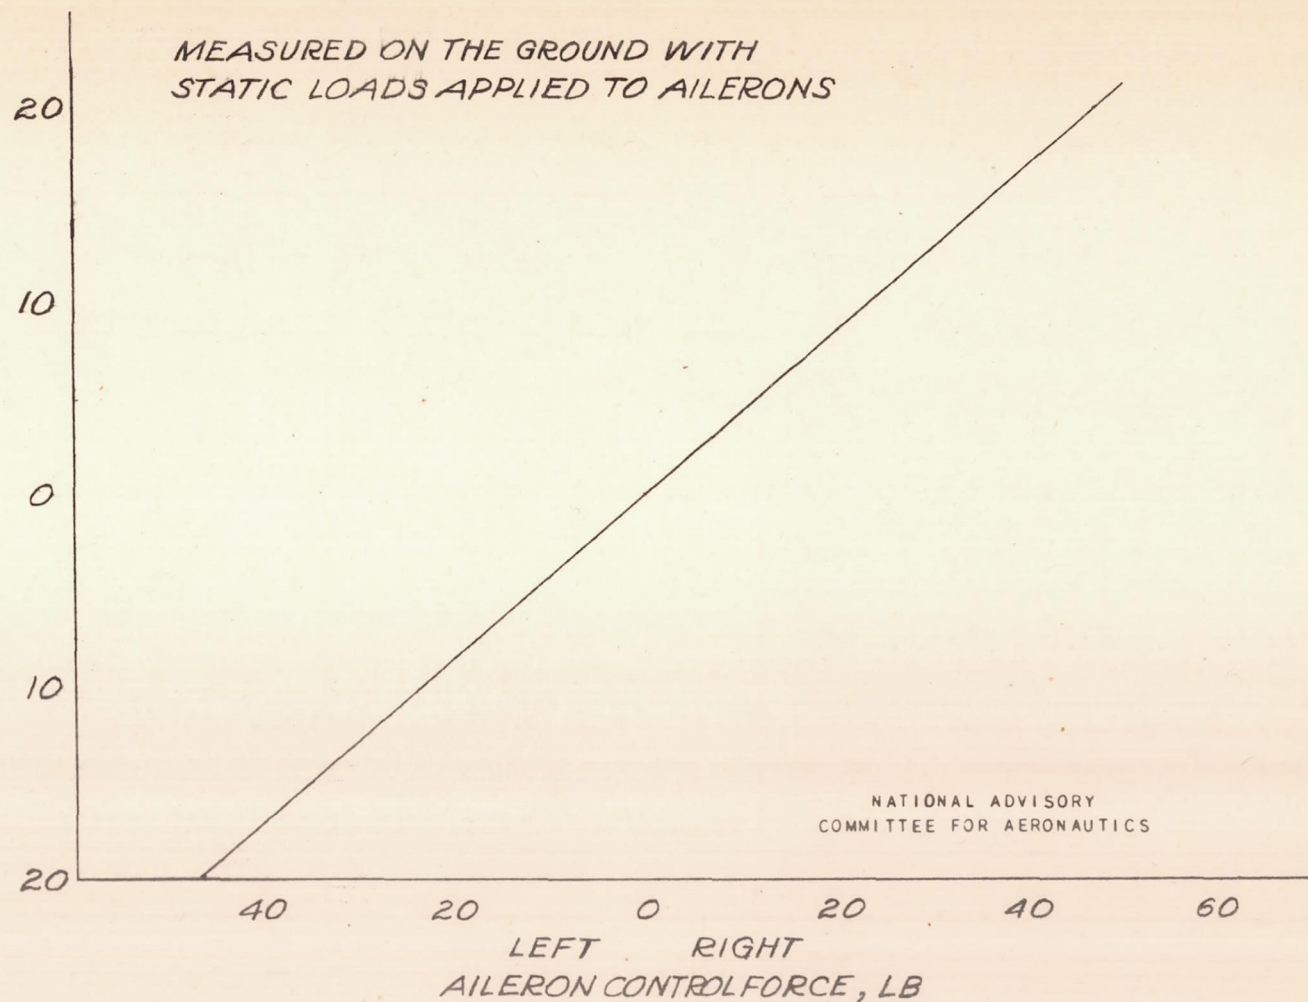
FIGURE 22.- VARIATION OF LATERAL CONTROL SYSTEM STRETCH WITH
AILERON CONTROL FORCE, CONTROL STICK NEUTRAL.

Control-system characteristics.— The elasticity or stretch in the lateral-control system in terms of the aileron angle as a function of the aileron control force as determined on the ground is presented in figure 22. From this relationship and from an average variation of aileron control force with total uncorrected aileron angle obtained in rudder-fixed aileron rolls, the ratio of the stretch to the corresponding static no-load uncorrected aileron angle is shown as a function of control force in figure 23 for three airspeeds. From those curves it is observed that the stretch in the system is considerably in excess of the limiting requirement (reference 4) that the stretch corresponding to a stick force of 30 pounds shall not exceed 20 percent of the static no-load aileron deflection.

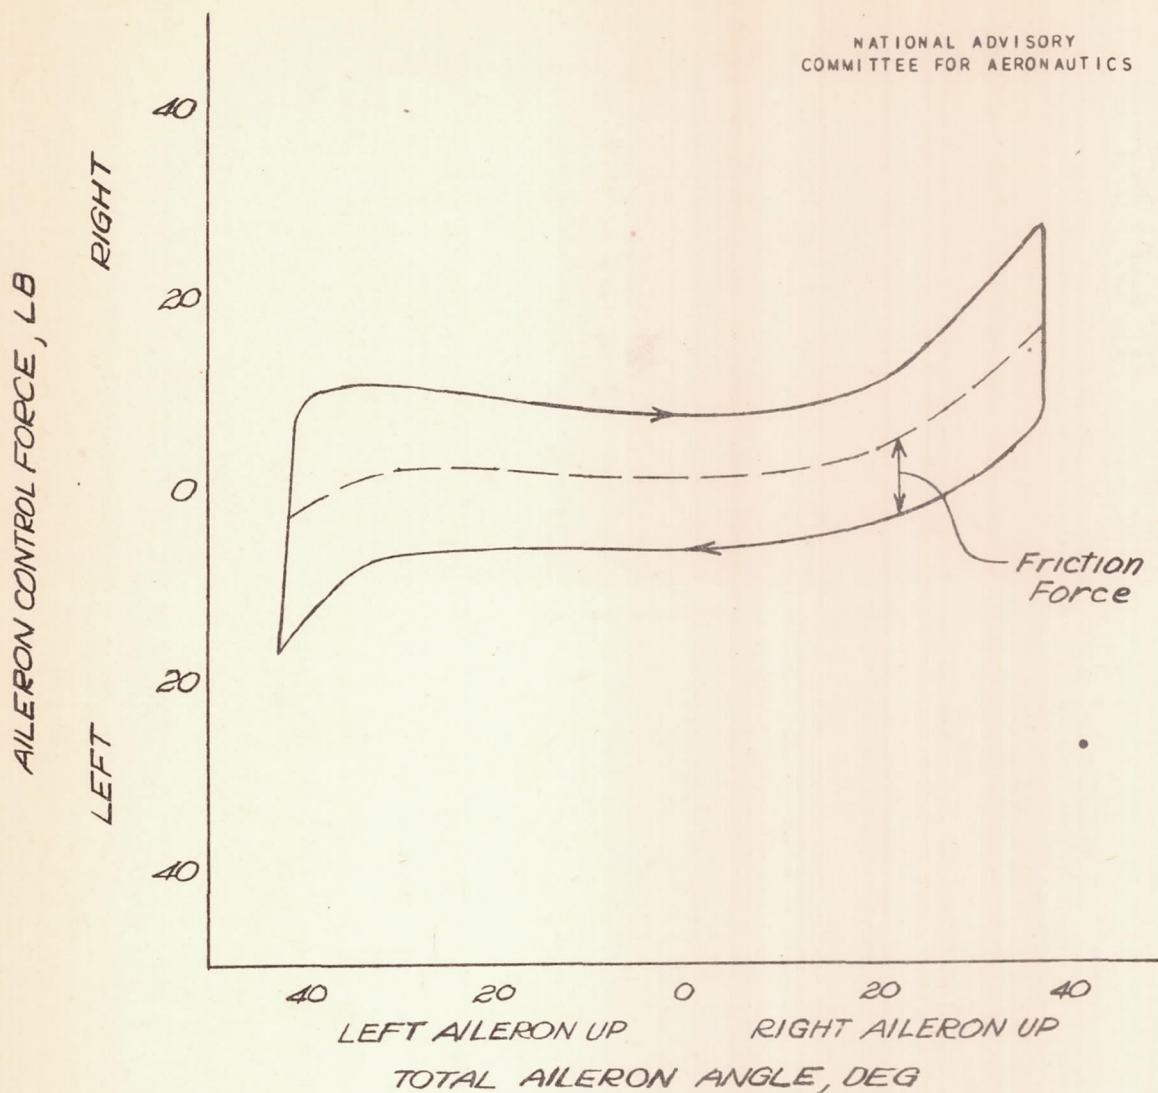
FIGURE 24.— VARIATION OF AILERON CONTROL FORCE WITH TOTAL AILERON ANGLE, NO LOAD ON SURFACES.

The friction in the lateral-control system with no load on the surfaces is shown in figure 24 to have an average value of 7.5 pounds. With the airplane in flight the average friction was 5.1 pounds for various power, flap, and speed conditions. A typical friction curve as obtained in flight is presented in figure 25. The friction in flight was slightly lower with power on than that with power off, due to the effects of engine and propeller vibrations. These friction forces are in excess of the maximum values of 1 and 4.5 pounds specified in references 3 and 4, respectively, as upper limits of friction in the lateral-control system.

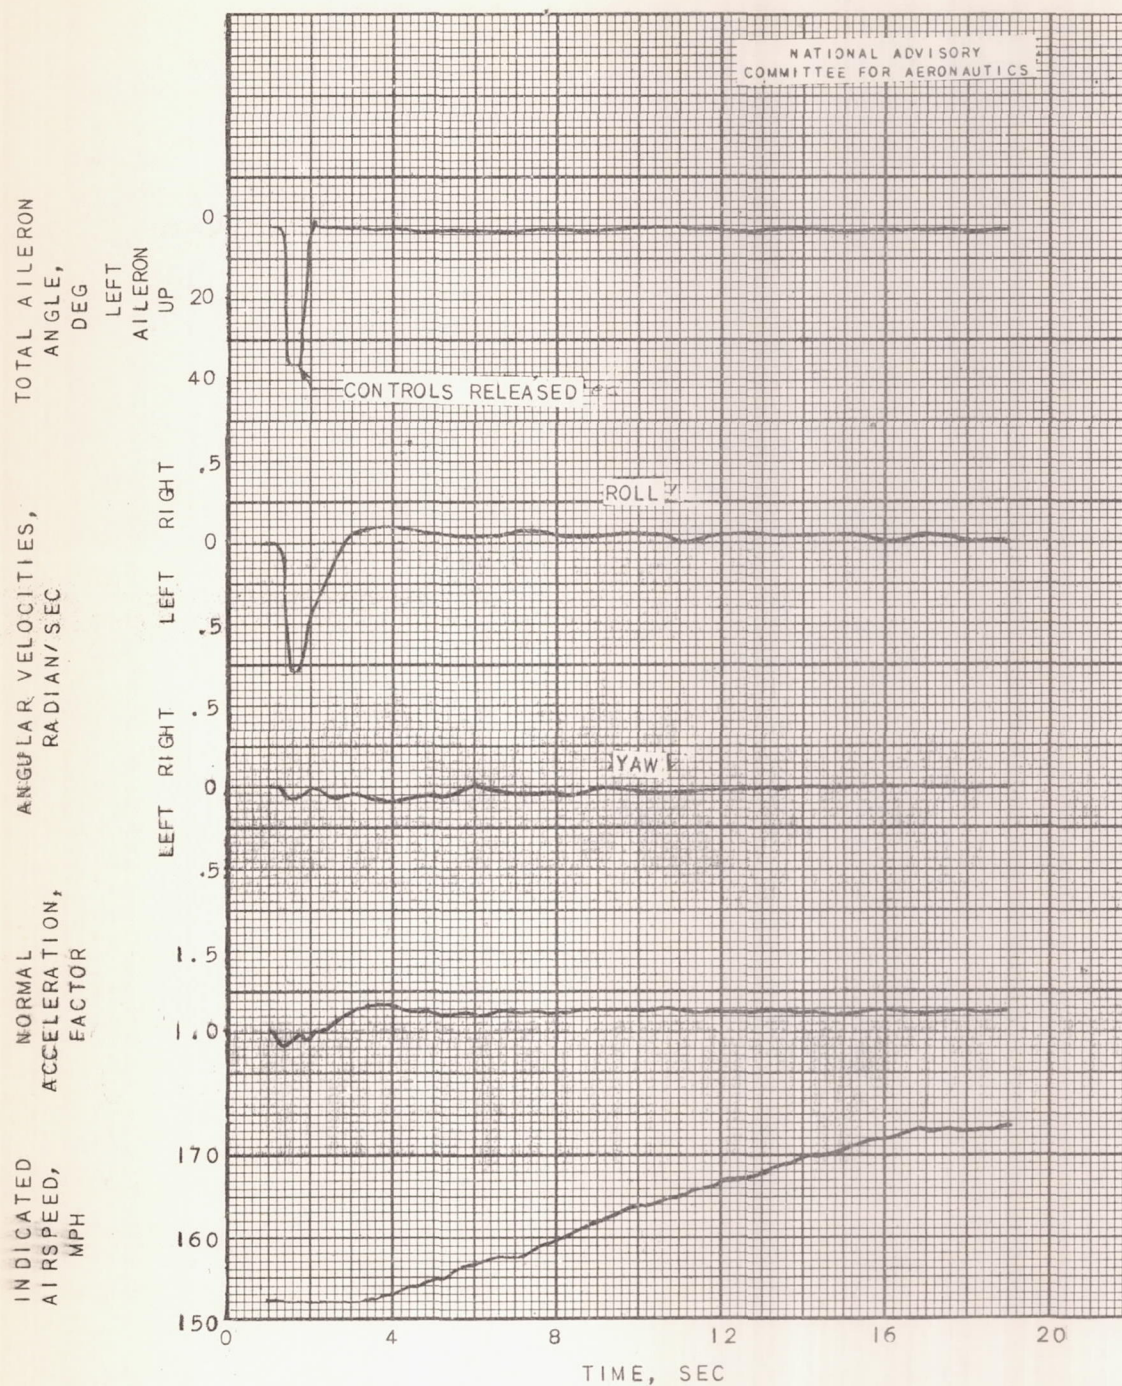
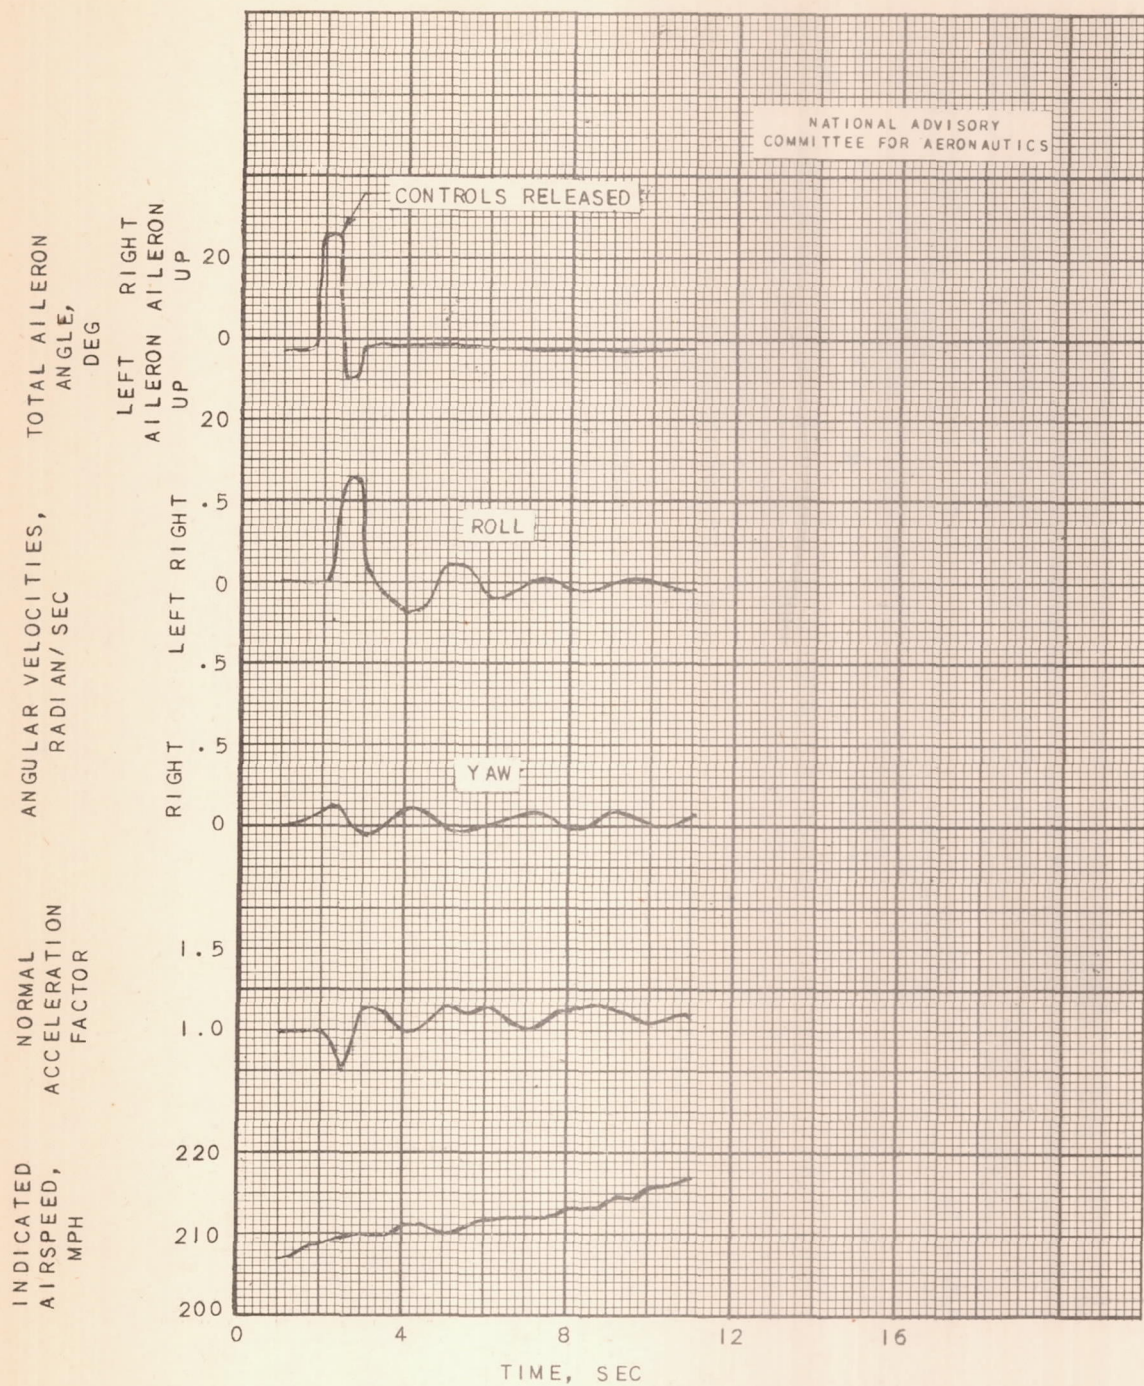
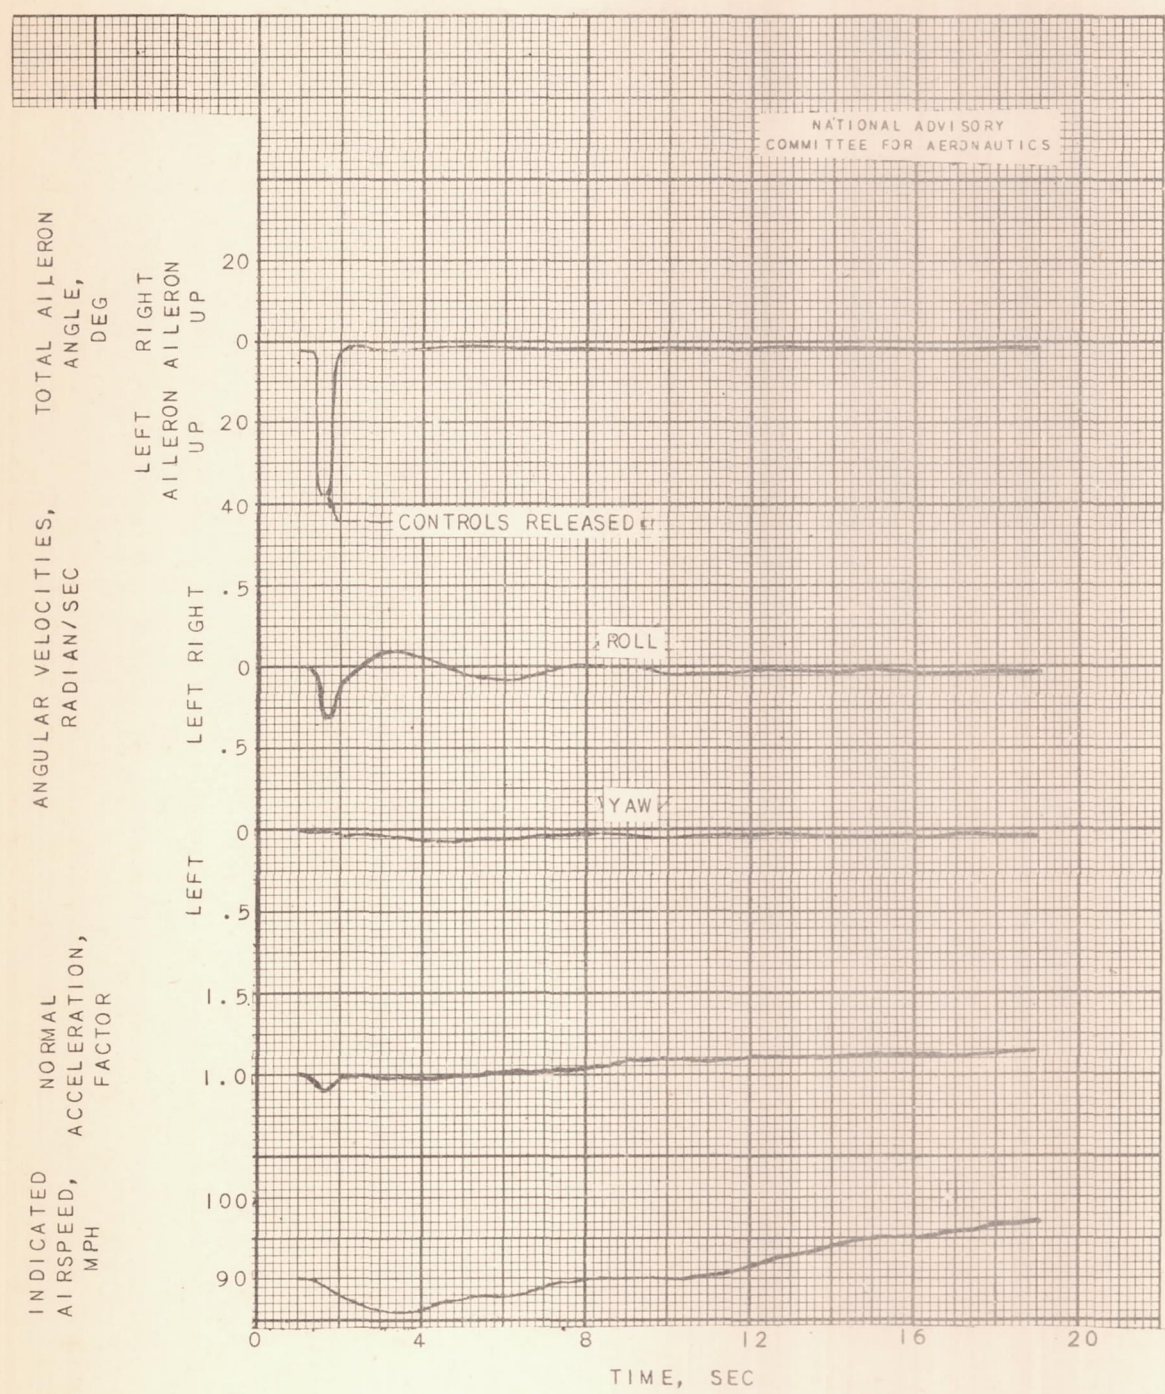
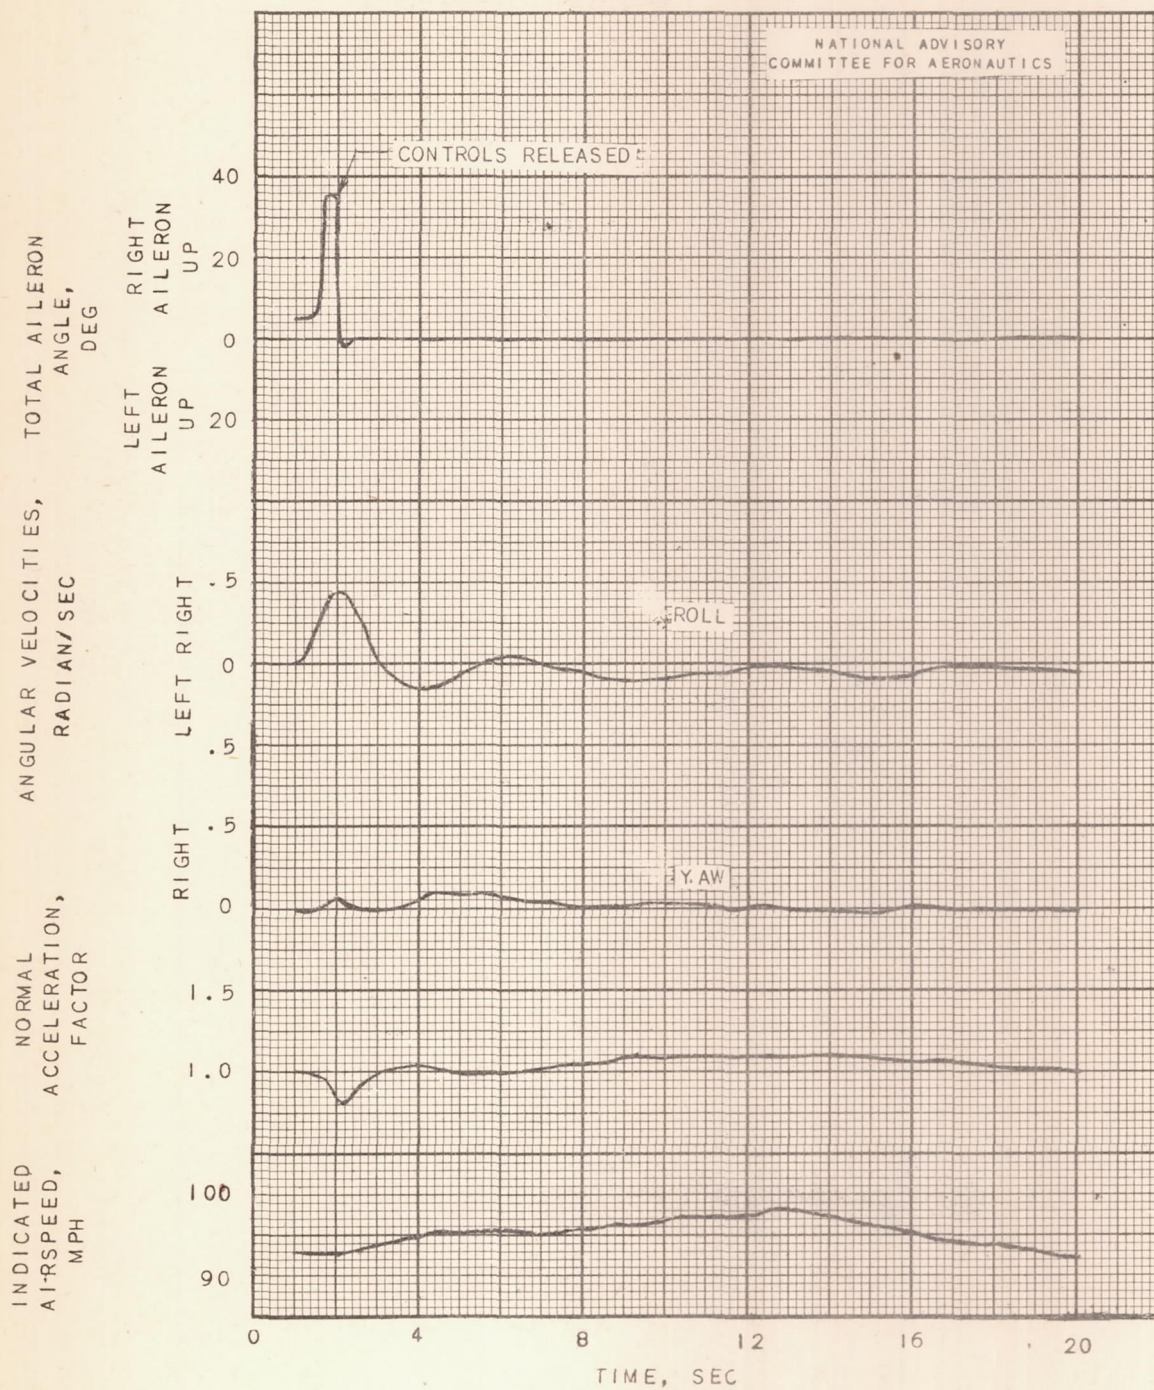
FIGURE 26. - CHARACTERISTICS OF UNCONTROLLED LATERAL MOTION, RATED POWER, FLAPS UP, 152 MPH.

FIGURE 27. - CHARACTERISTICS OF UNCONTROLLED LATERAL MOTION, RATED POWER, FLAPS UP, 207 MPH.

FIGURE 28. - CHARACTERISTICS OF UNCONTROLLED LATERAL MOTION, POWER OFF, FLAPS UP, 92 MPH.

FIGURE 29. - CHARACTERISTICS OF UNCONTROLLED LATERAL MOTION, POWER OFF, FLAPS DOWN, 92 MPH.

Characteristics of uncontrolled lateral motion.— The characteristics of the control-free lateral oscillation are indicated by the time histories of figures 26 to 29. It is seen that in every test condition the motions damped to one-half amplitude in less than two cycles as recommended by the requirements of reference 5 except in the case of rated power, flaps up, and 207 miles per hour where the yawing velocity was not adequately damped. When the ailerons were deflected and released quickly, they returned to their trim position in all cases except at low deflections and low speeds. The fact that the ailerons were able to overcome the high friction force and return to neutral was undoubtedly due to the large inertia in the system. Any oscillations of the ailerons themselves in all cases disappeared after one cycle.
